ADVANCED COMPOSITE ELEVATOR FOR BOEING 727 AIRCRAFT VOLUME 2—FINAL REPORT

Boeing Commercial Airplane Company
P.O. Box 3707, Seattle, WA 98124

CONTRACT NAS1-14952
NOVEMBER 1980

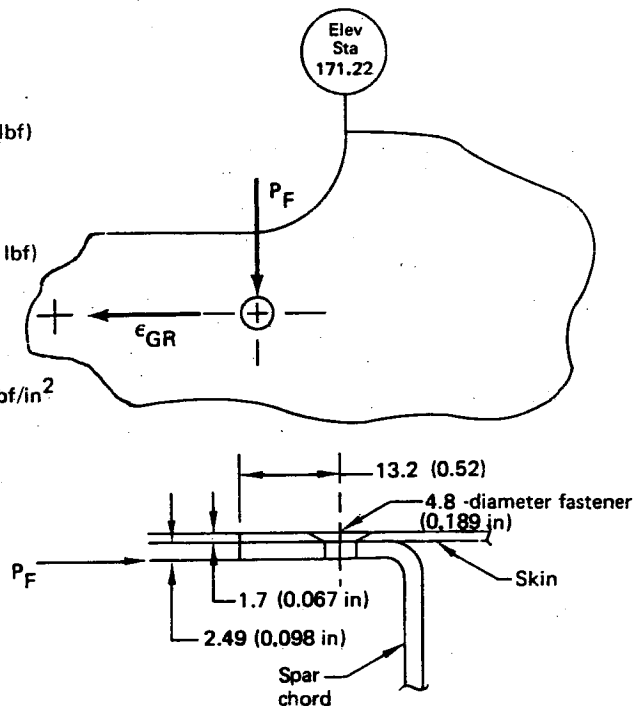
Figure 132. Fail-Safe Loading Failure Analysis

- Load from hinge fitting, $P_F = 5.0 \text{ kN (1124 lbf)}$

$$\epsilon_{GR} = 0.0042 \text{ mm/mm (in/in)}$$

The failure in the tension skin passed through the spar/skin fastener at station 172, as shown in Figure 131. The loads that existed at the analysis location were the bypass strain due to overall elevator bending and a fastener bearing stress due to the hinge loads. The fastener bearing stress acts normal to the bypass strain. Figure 132 presents the calculations that were used to obtain the bypass strain and bearing stress.

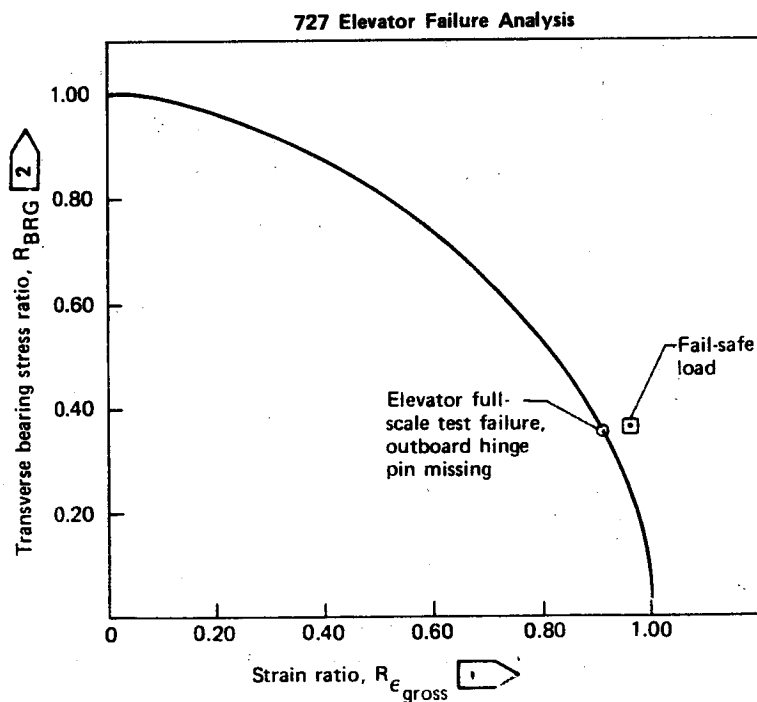
① $R_{\epsilon_{gross}}$ of 1.00 based on $\epsilon_{gross} = 0.0046 \text{ mm/mm, (in/in)}$, from room temperature, dry test specimens (fig 71)

② R_{BRG} of 1.00 based on $f_{BRG} = 709 \text{ MPa (102 800 lbf/in}^2\text{)}$ from room temperature, dry test specimens (fig 63)

Test data from the ancillary test program were reviewed and room-temperature/dry test values of bearing stress and bypass strain that would apply in the failure area were obtained. The maximum fastener bearing stress was established as 709 MPa (102 800 lbf/in²) (fig. 68) and the maximum bypass strain was established as 0.0046 mm/mm (in/in) (fig. 71). These values are plotted on an interaction curve of fastener bearing stress versus bypass strain in Figure 133. The values of bearing stress and bypass strain that existed on the elevator at failure, from Figure 132, are plotted in Figure 133. The test point, displayed in Figure 133, defines an interaction curve for combining fastener bearing stress normal to a tension bypass strain. The 100% level of the fail-safe load condition is plotted in Figure 133 as a reference.

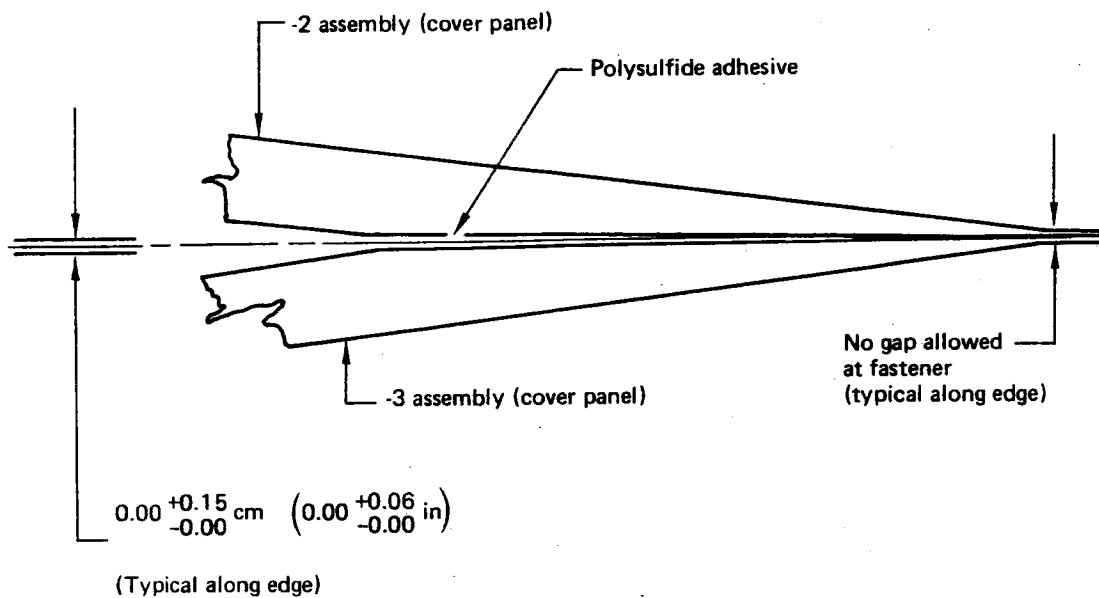
Figure 142. Trailing-Edge Tolerance

Tooling and processing methods were developed in this study to maintain 0.15-cm (0.06 in) bondline tolerance between cover panels at the elevator trailing edge (fig. 142). These methods were used in the fabrication and assembly of the test and verification hardware and the five and a half production shipsets. A brief description of the methods follows.

Improved Bonding Surfaces—Use of a caul plate during cure to fair out bond surfaces at the trailing edge minimized interference fit between the cover panels during assembly (fig. 142).

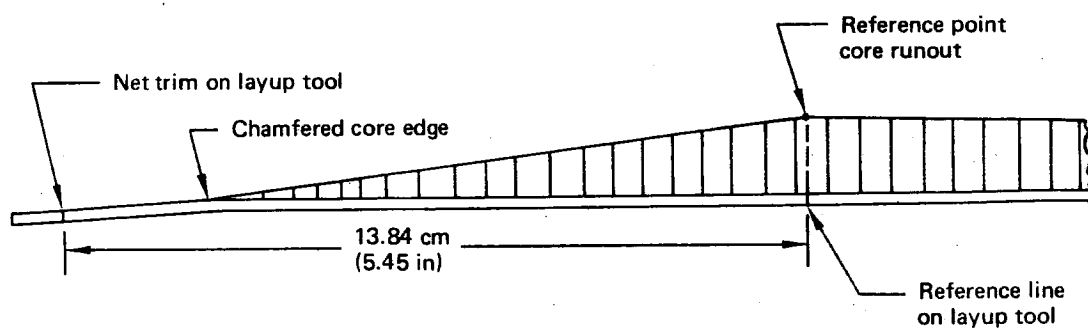
Figure 143. Core Locating Method

Improved Core Location—The core runout, as opposed to the chamfered edge, was used as the reference point for locating the core on the tool (fig. 143).

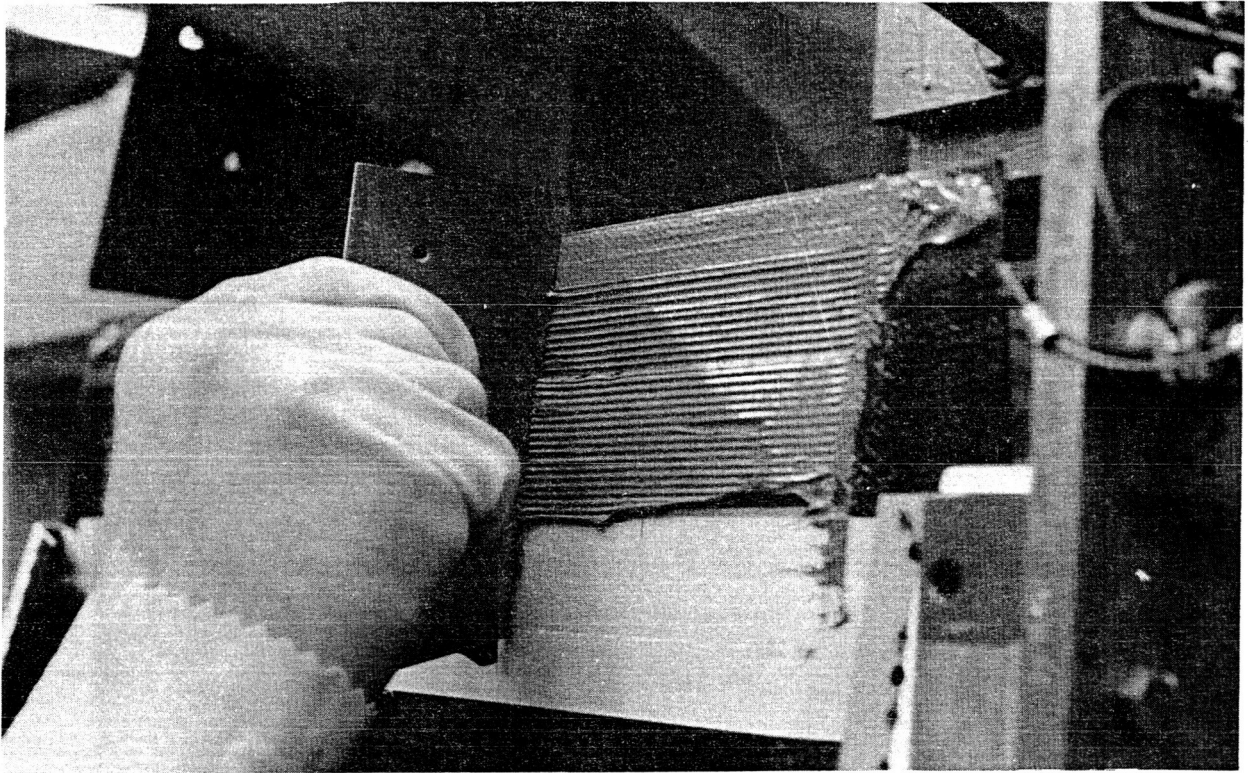
Figure 144. Application of Trailing-Edge Sealant and Adhesive

Adhesive Application and Assembly—The amount of adhesive applied was controlled by use of a serrated sweeper having proper pitch and spacing, as illustrated in Figure 144. The holding fixture (fig. 145) was designed and constructed to hold the skins in alignment and provide controlled sealant flow during cure.

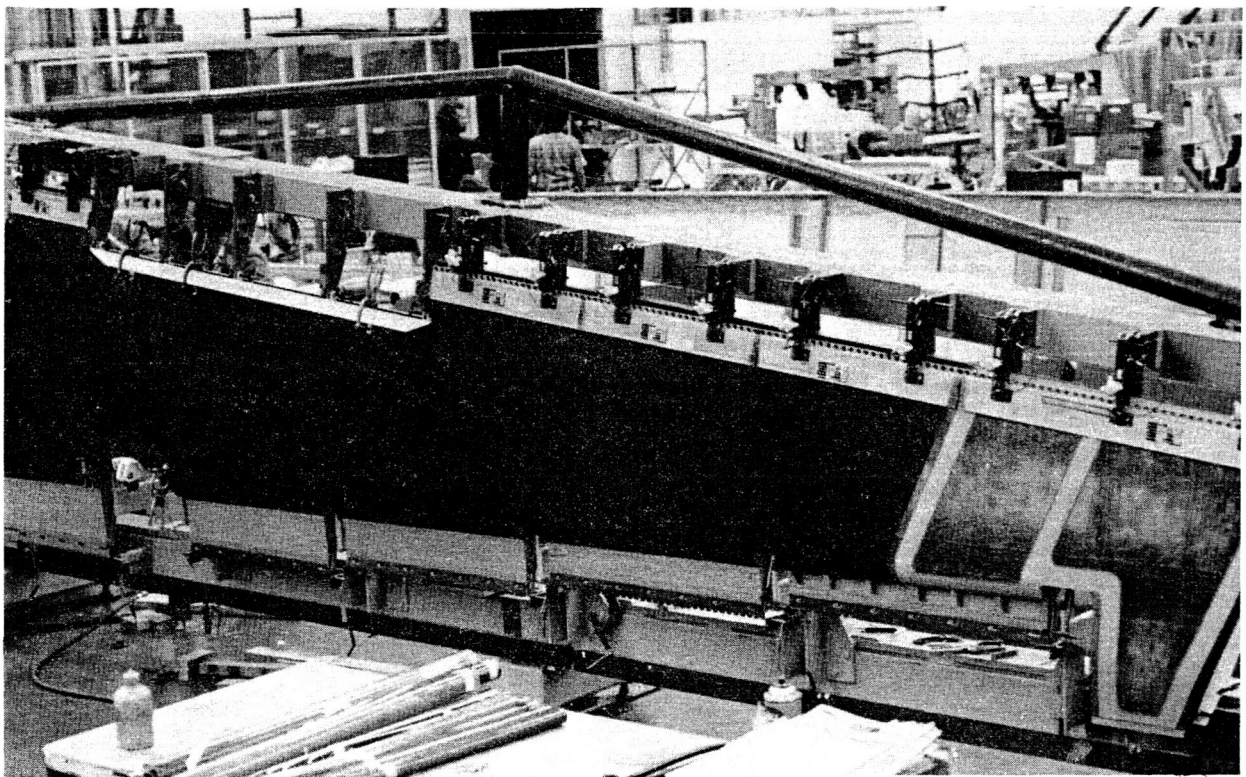
Figure 145. Elevator Major Jig Position Showing Upper Skin Panel in Position During Sealant Cure

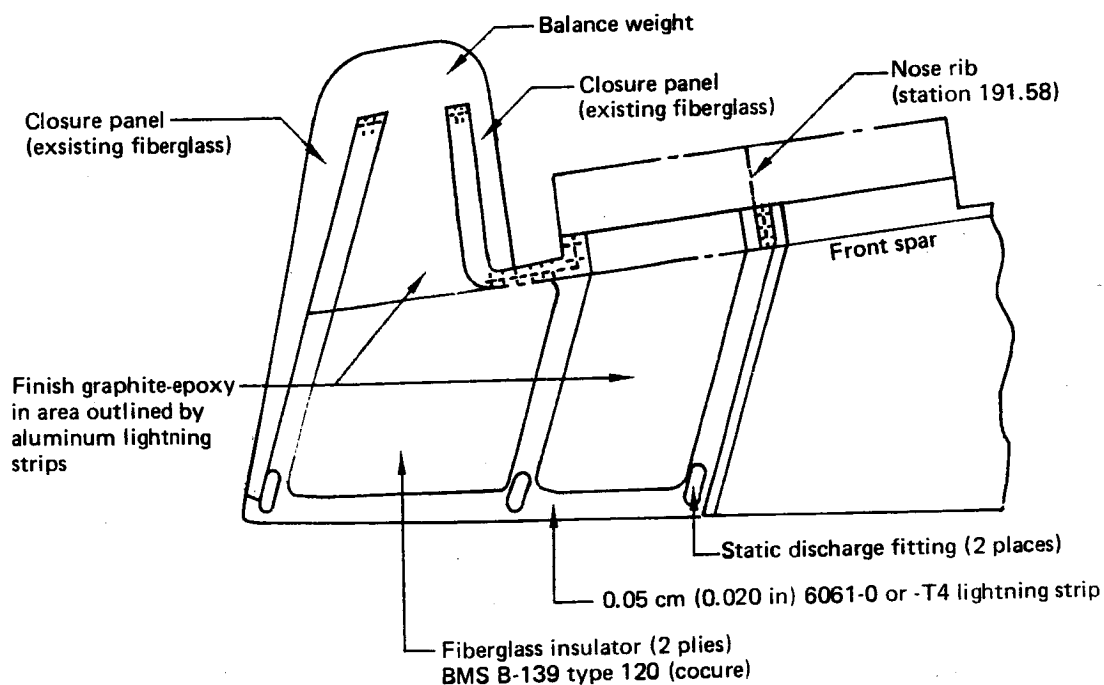
Figure 146. Lightning Strike Panel

To provide the required lightning strike protection of the elevator outboard tip, a 0.05-cm (0.02-in) thick aluminum strip was bonded to the upper cover panel (fig. 146 and 147). A full-size lightning strike protection panel was fabricated for test and to verify the manufacturing technique for bonding the aluminum strips on the outer surface. The selected bonding process consisted of:

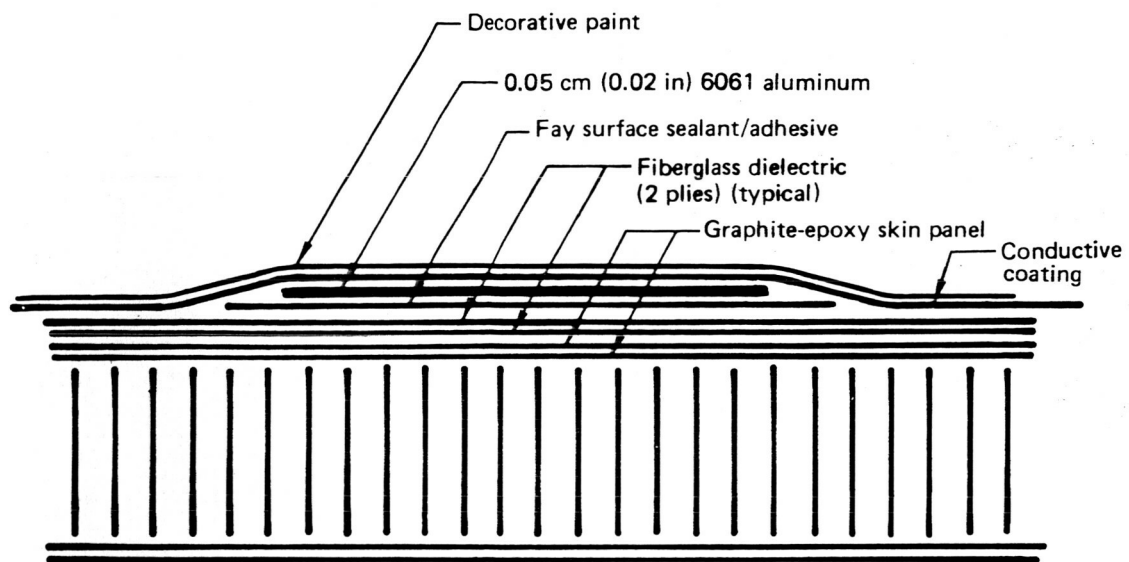
Figure 147. Layup of Lightning Protection System

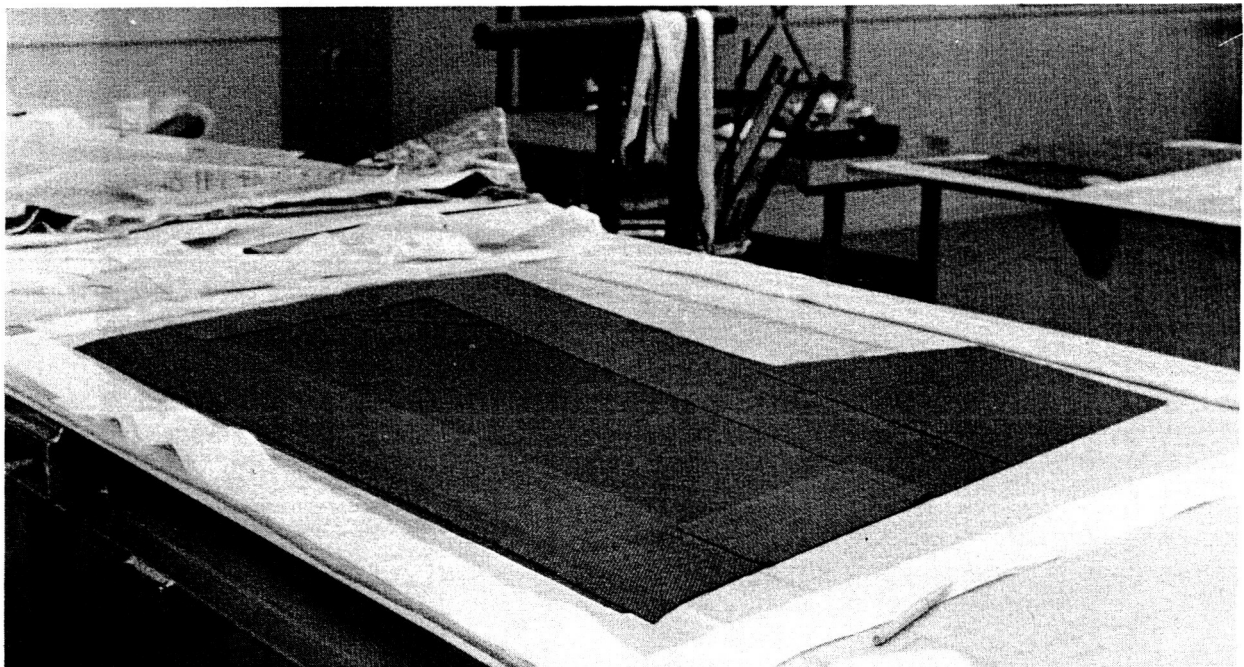
Figure 148. Lightning Strike Panel Showing Layup of Doublers and Outer Skin

Layup of graphite-epoxy skins and Nomex core is shown in Figures 148 through 152. The aluminum strip bonded on the outside mold line (OML) of the test panel, using polysulfide adhesive and under vacuum pressure, is shown in Figure 152. After bonding, a protective finish system was applied that consisted of:

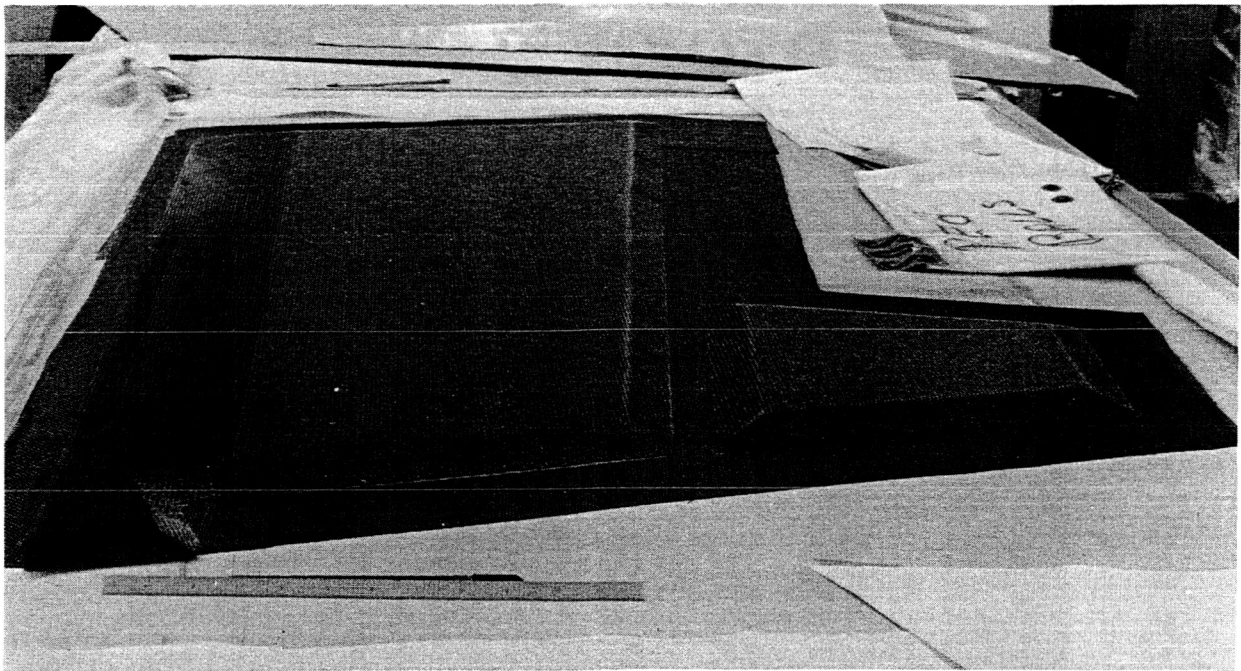
Figure 149. Lightning Strike Panel Showing Core in Place on Outer Skin

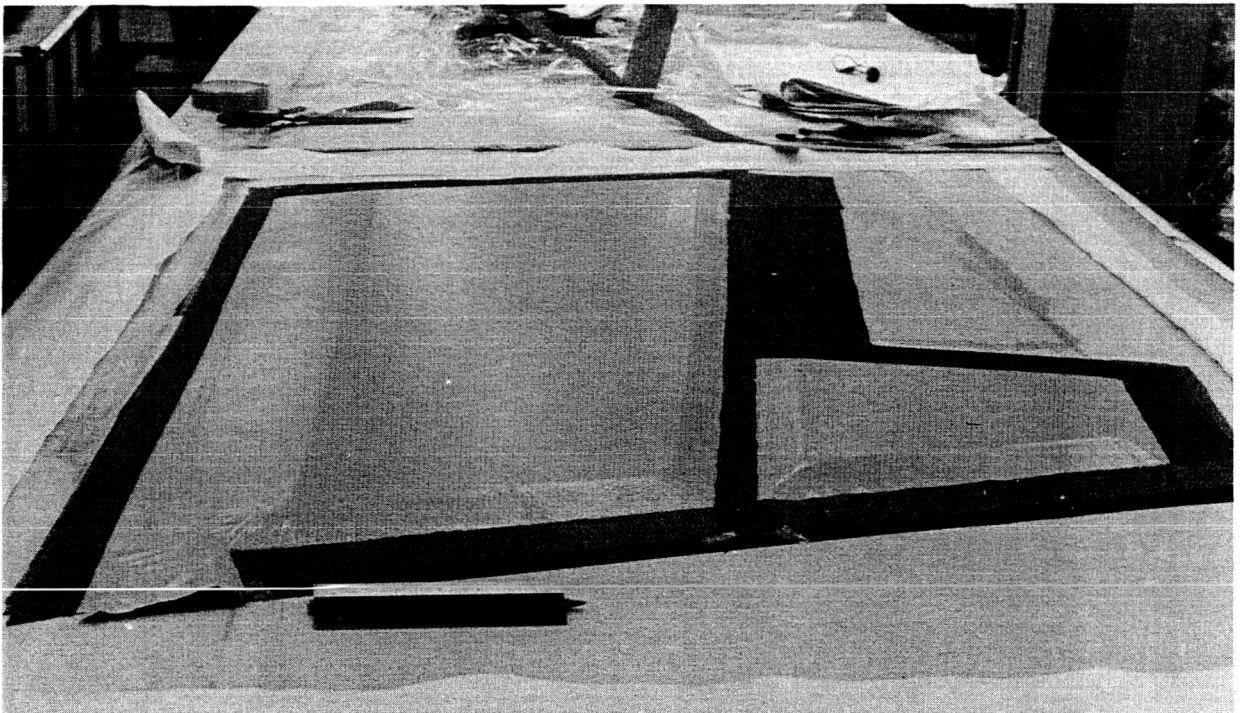
Figure 150. Lightning Strike Panel Showing FM 300 Adhesive on Core

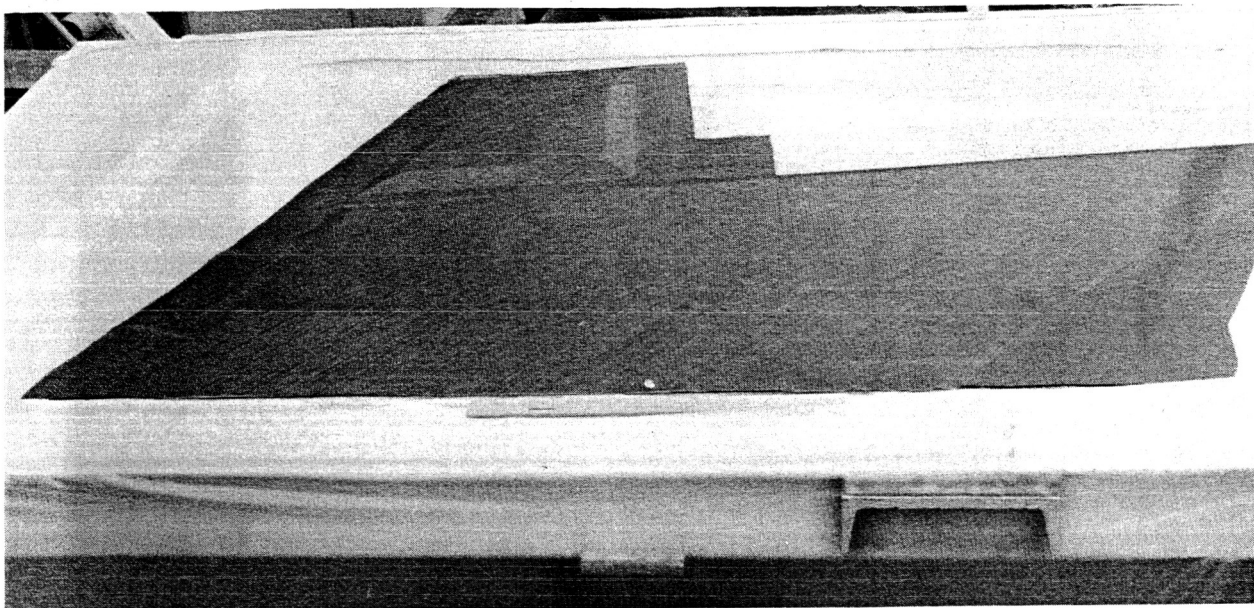
Figure 151. Lightning Strike Panel Showing Completed Layup Ready For Bagging

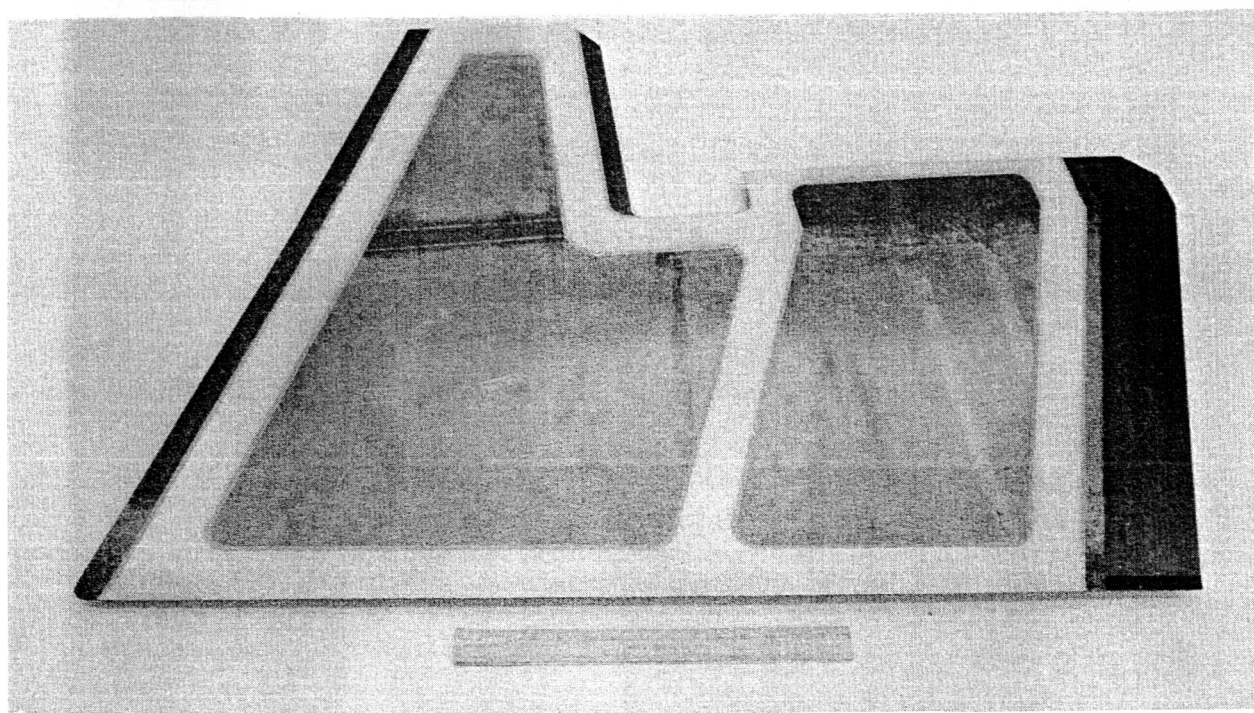
Figure 152. Lightning Strike Panel with Bonded Aluminum Strip

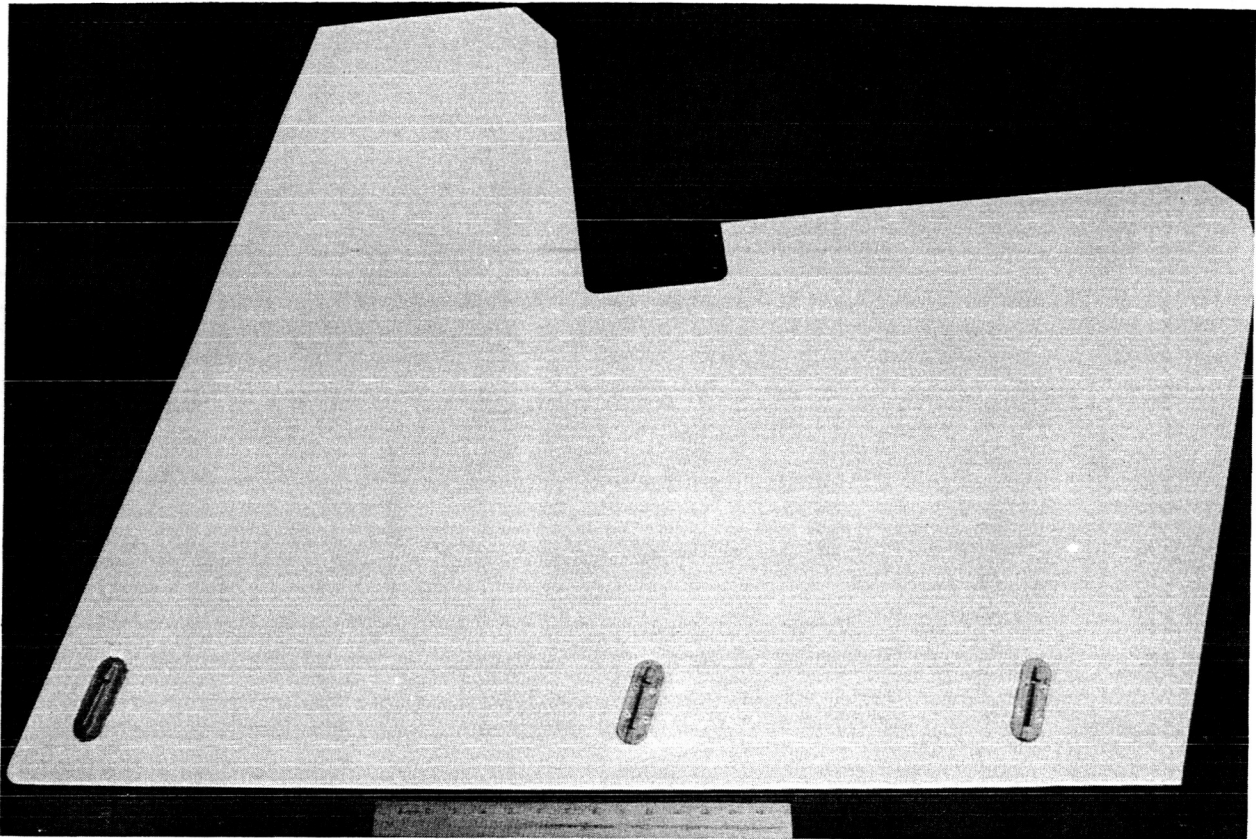
Figure 153. Lightning Strike Panel—Finished Part Ready for Test

The finished panel, with static dischargers attached, is shown in Figure 153.

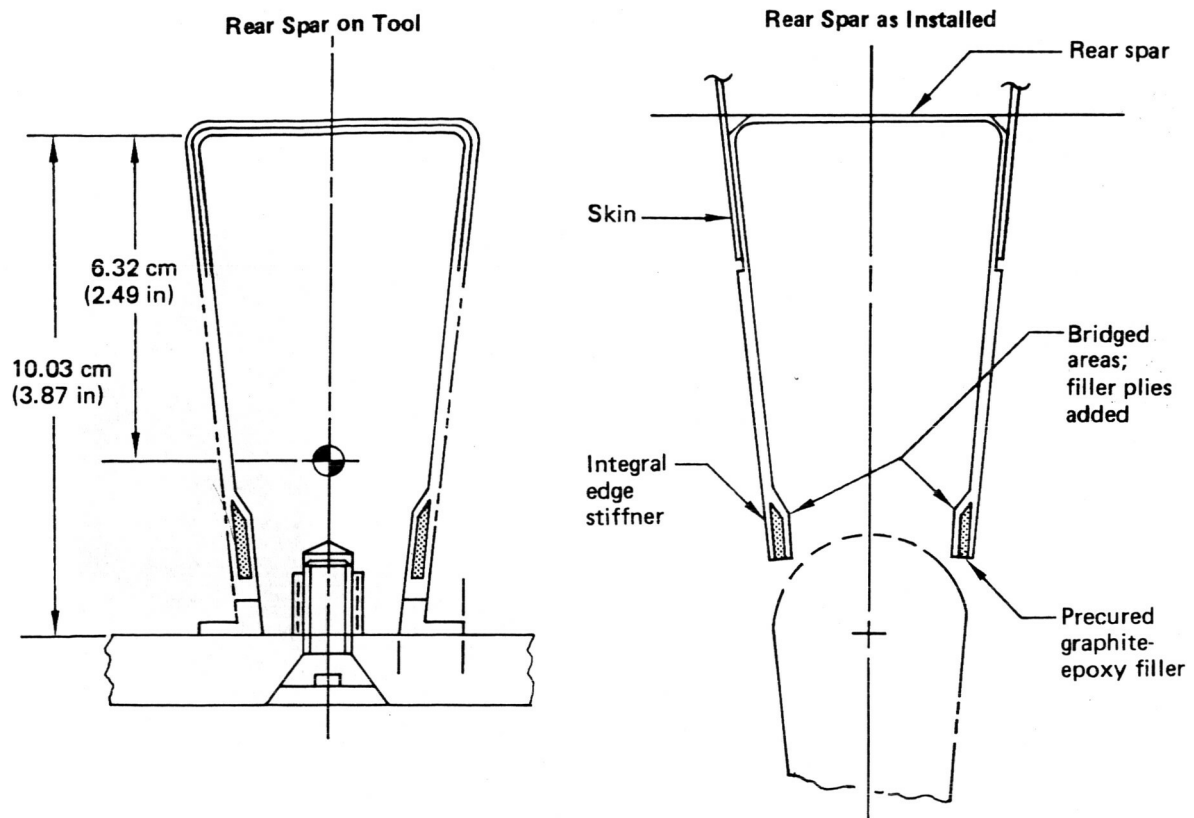
Figure 154. Rear-Spar Feasibility Hardware

The first test part verified the one-piece tooling concept and design; the closed angle was easily sprung from the tooling. There was, however, some bridging in the radius areas at the upper edge of the precured filler (fig. 154). To remedy this condition, tape plies were added to the filler radii of a second test part and exterior pressure plates were added to provide a smooth transition across the spar surface in the area opposite the radii. Additionally, warpage of 0.91 cm (0.36 in) in the spanwise direction was corrected by changing the unidirectional tape layup of the precured filler to a quasi-isotropic layup of fabric. Warpage of 0.13 cm (0.05 in) on the second test spar could be eliminated with slight hand pressure and was, therefore, acceptable.

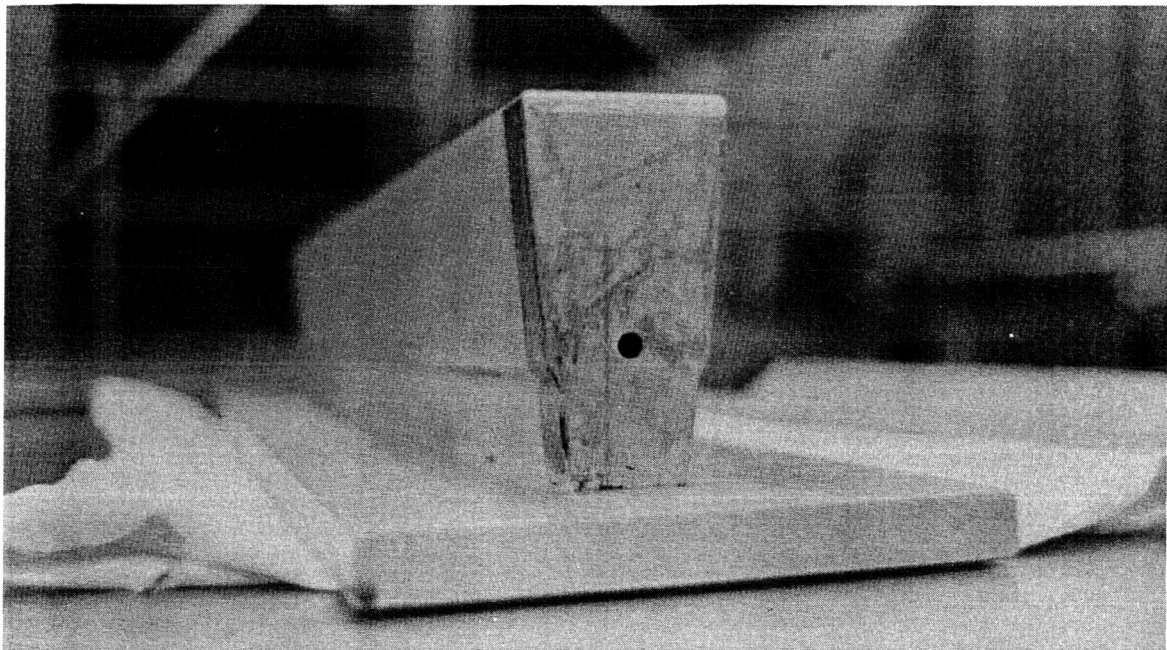
Figure 155. Rear-Spar Layup Material

The improved design of the rear spar (fig. 9), incorporating the trailing-edge stiffeners as an integral part of the spar and eliminating one row of riveting, required the tool design and process development illustrated in Figures 154 through 159.

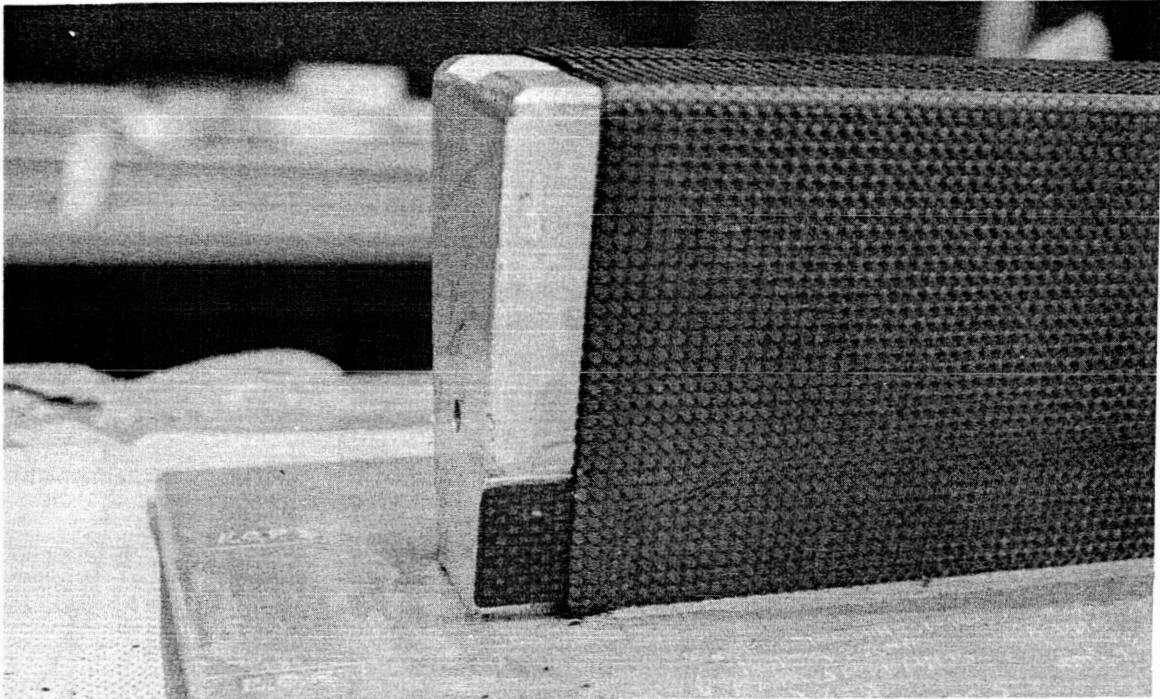
Figure 156. Rear-Spar Test Part Showing Initial Ply Layup Before Precured Filler

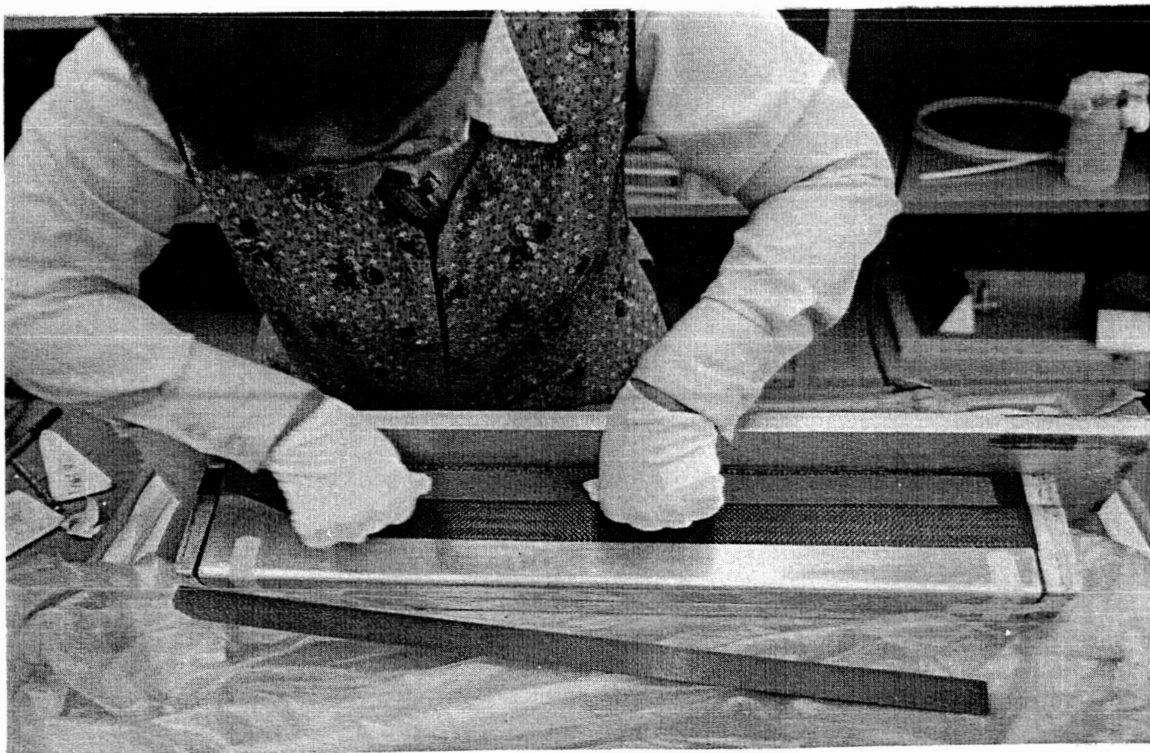
Figure 157. Rear-Spar Test Part Showing Application of Adhesive for Precured Filler

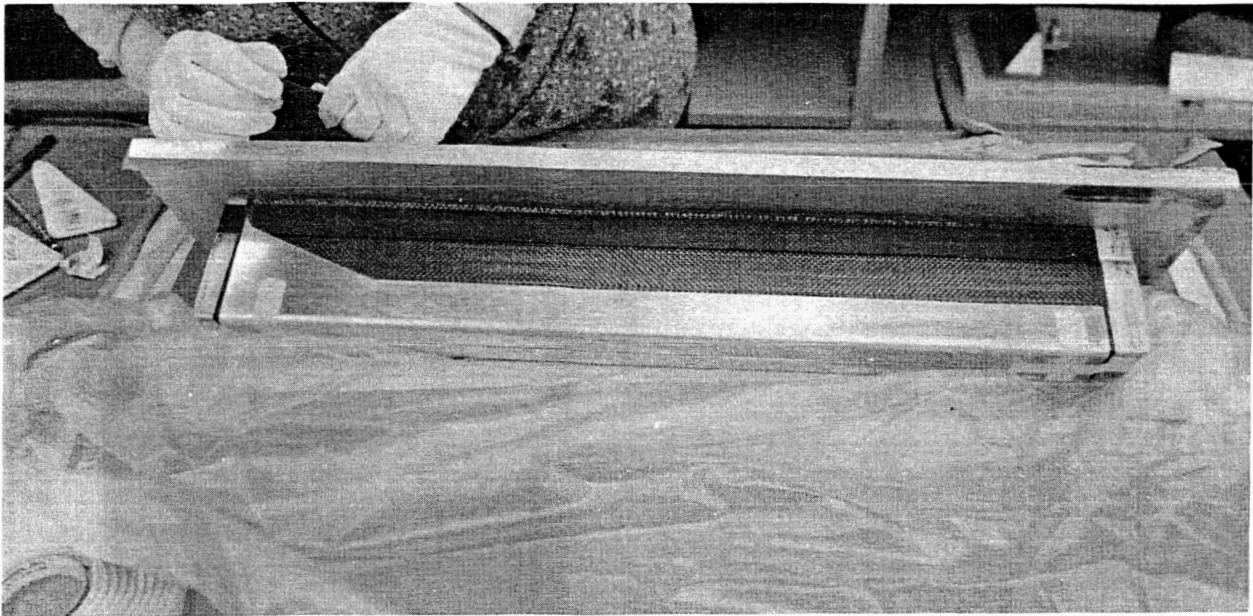
Figure 158. Rear-Spar Test Part Showing Location of Precured Filler

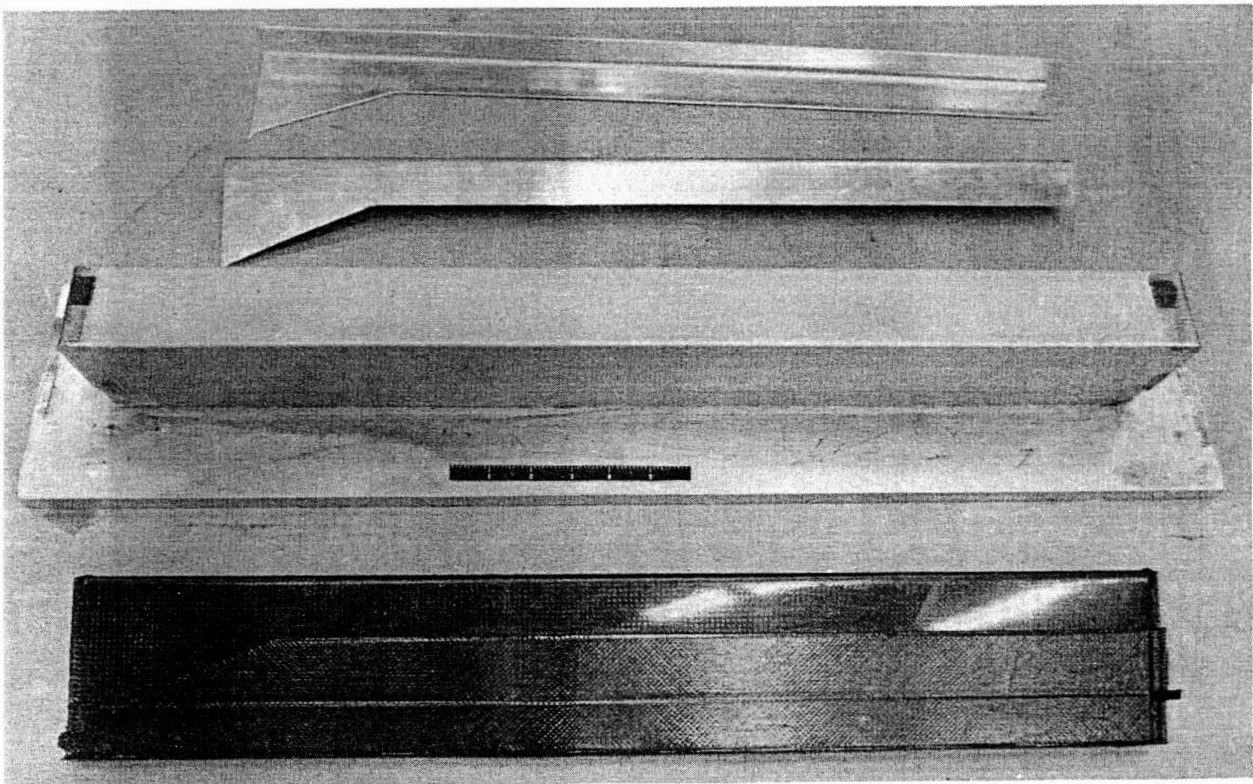
Figure 159. Rear-Spar Test Part Showing Finished Part With Tooling

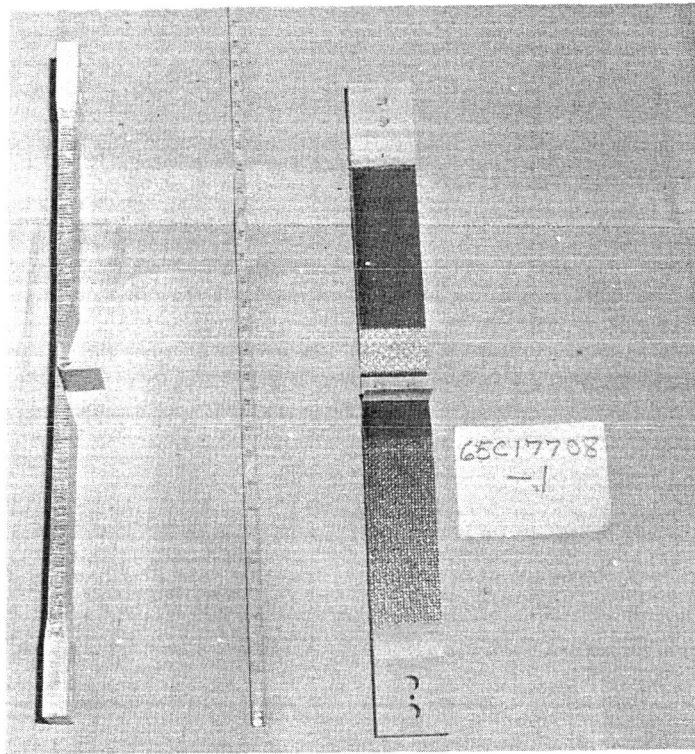
Figure 160. Panel-to-Rib Pad (Test 8) Showing Typical Test Specimen

- Panel-to-rib pad, Test 8 (fig. 160)
- Spar/aluminum splice, Test 11 (fig. 161)
- Honeycomb panel stability, Test 10 (fig. 162)
- Panel edge shear, Test 12
- Rib design, Test 14; shown on layup tool in Figure 163
- Sonic test box, Tests 15 and 18 (figs. 164 through 166)
- 10-ft outboard test box, Test 17 (figs. 167 through 169)

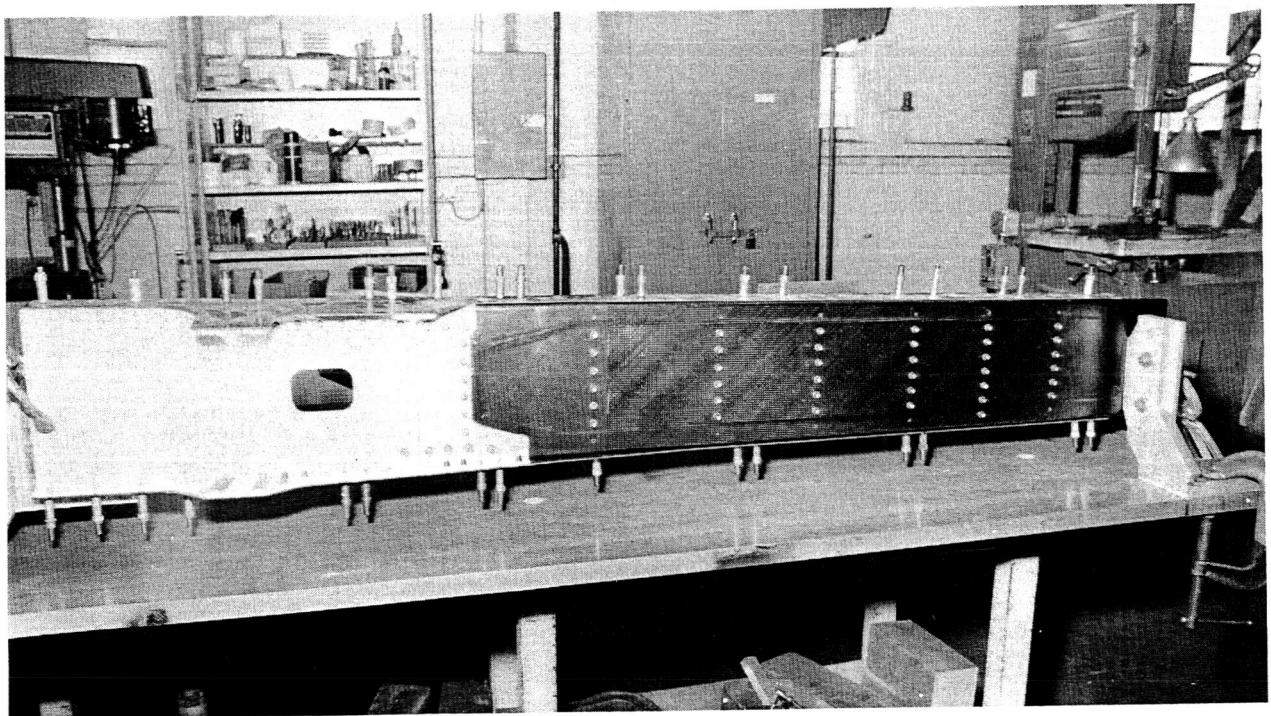
Figure 161. Spar/Aluminum Splice (Test 11) Showing Test Part Being Assembled

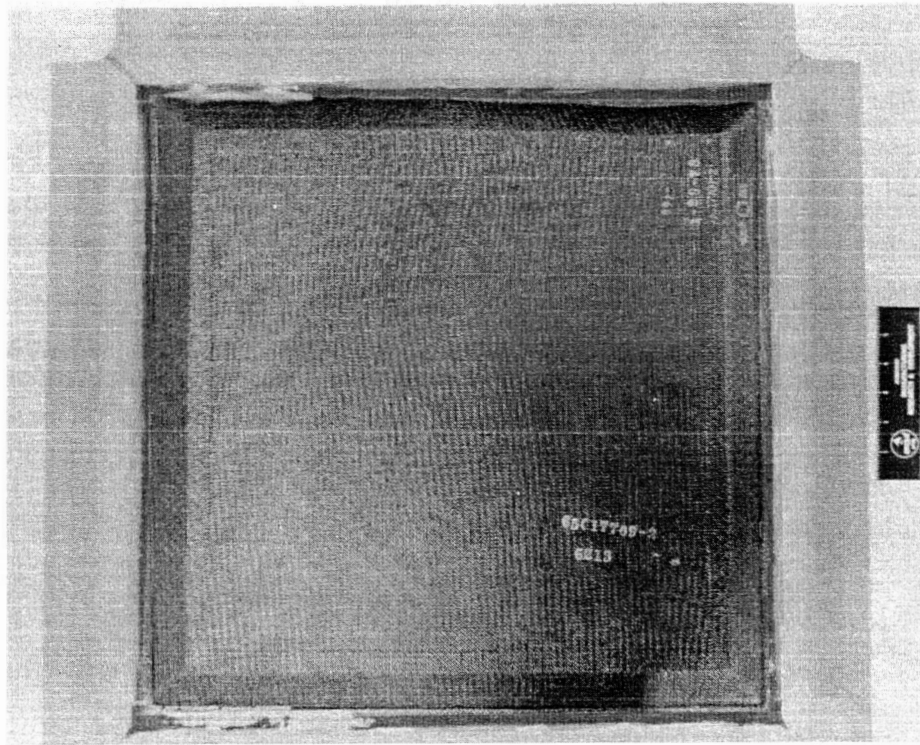
Figure 162. Honeycomb Panel (Test 10) Showing Honeycomb Panel with Grips

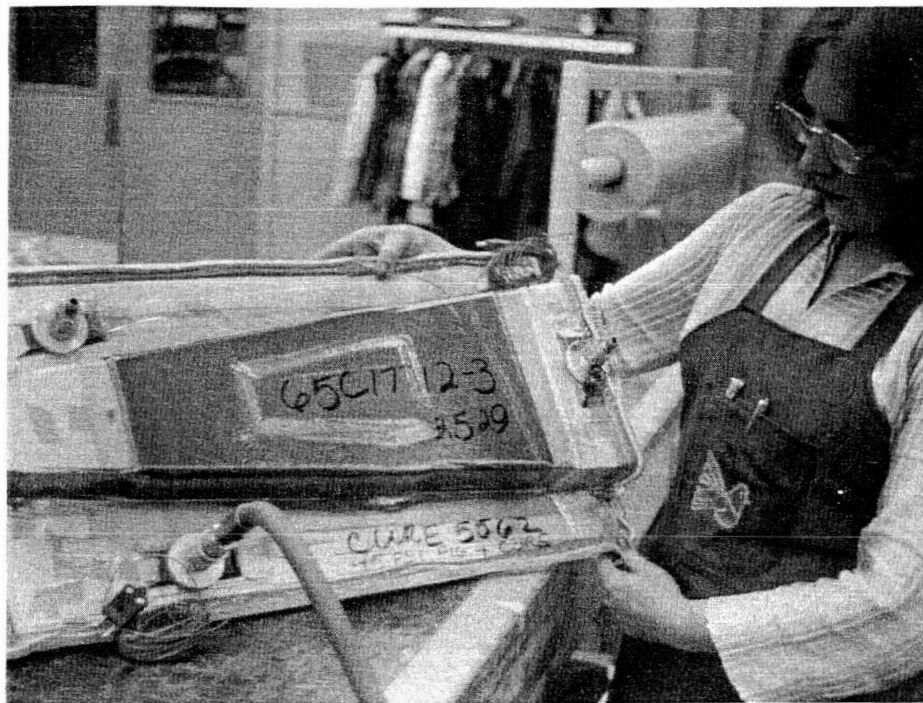
Figure 163. Rib Verification (Test 14) Showing Rib Ready for Cure

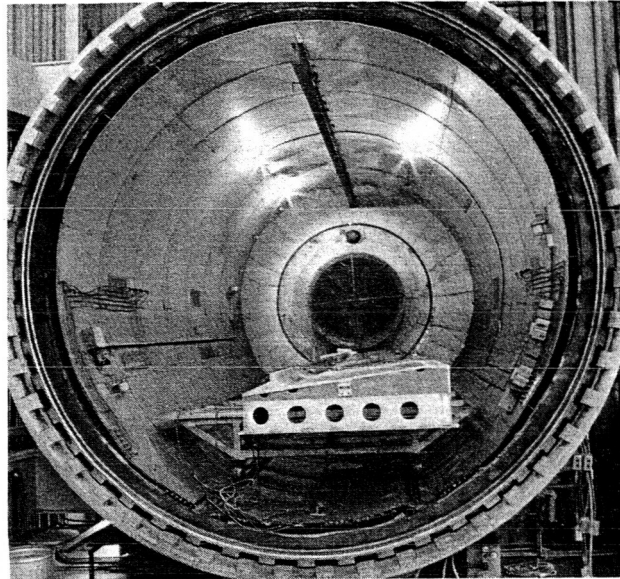
Figure 164. Second Sonic Box (Test 18) Showing Skin Panel in Autoclave

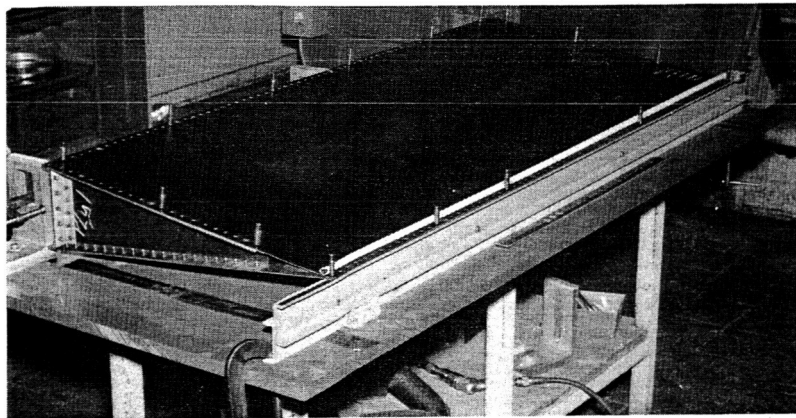
Figure 165. Sonic Test Box (Test 15) Showing Test Box Being Assembled

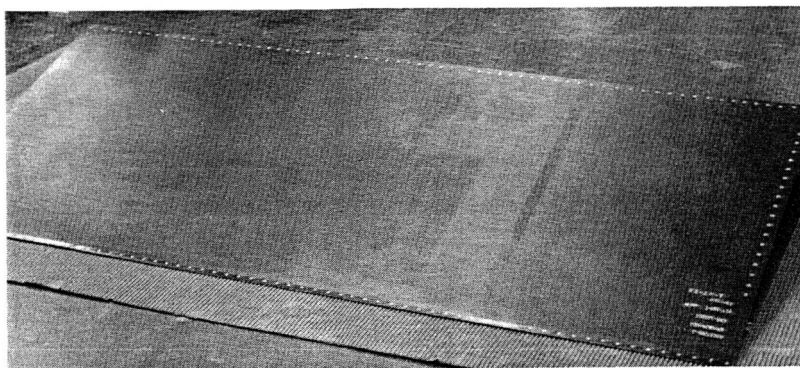
Figure 166. Sonic Test Box (Test 15) Showing Assembled Test Box

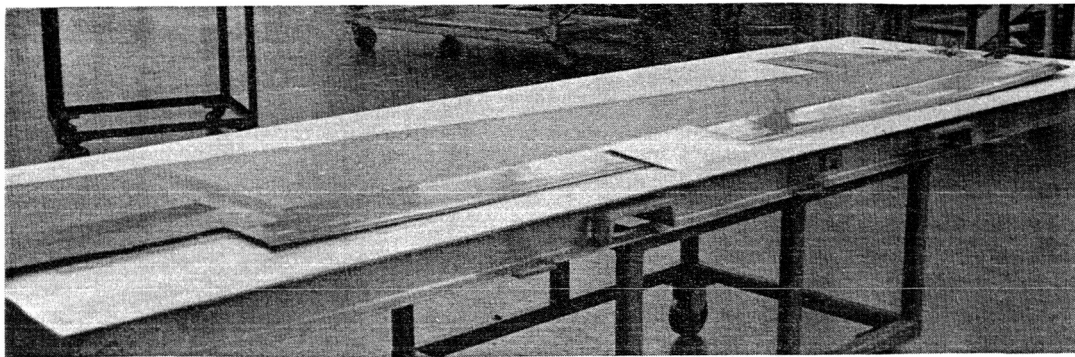
Figure 167. 10-ft Test Box (Test 17) Showing Complete Cover Panel

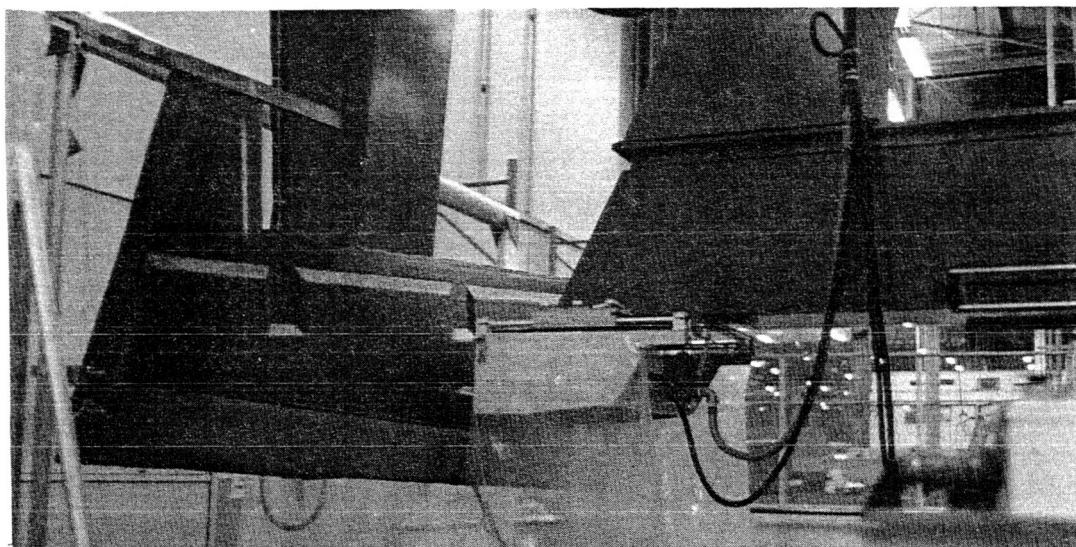
Figure 168. 10-ft Test Box (Test 17) Showing Cover Panel Being Inspected by Through-Transmission Ultrasonic

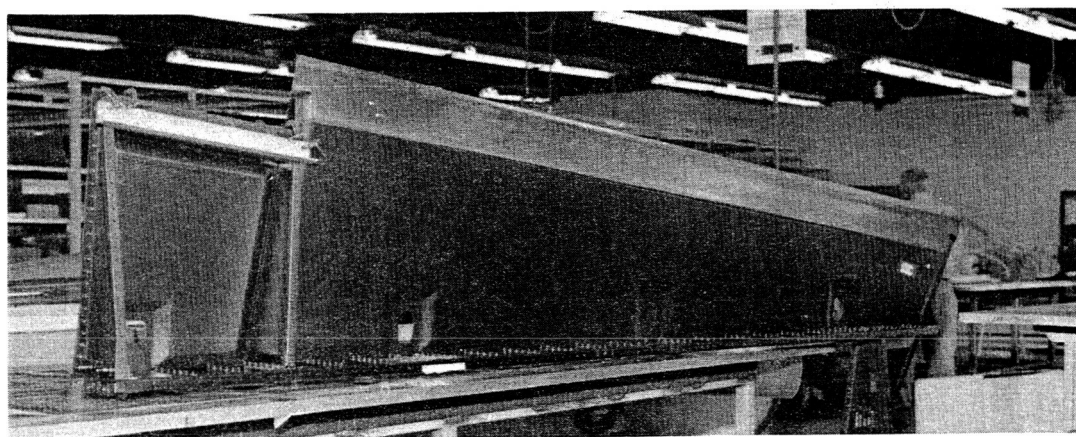
Figure 169. Assembly of Test 17 Outboard Test Box, Showing Assembled Lower Skin, Ribs, and Rear Spar

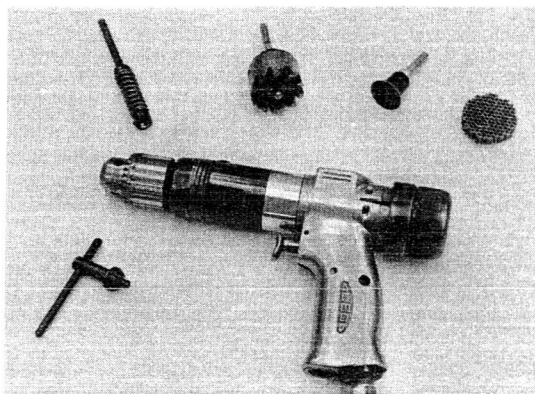
*Figure 170. Sonic Test Box (Test 15)
Equipment Used in Repairing
Damage to Test Box*

To repair accidental impact damage to the honeycomb skin panel of the sonic test box, the following procedure (illustrated in fig. 170 through 175) was developed and used:
